Pilot Cooling Tower Study

Performed for HydroFlux Technology, LLC

Objective & Executive Summary

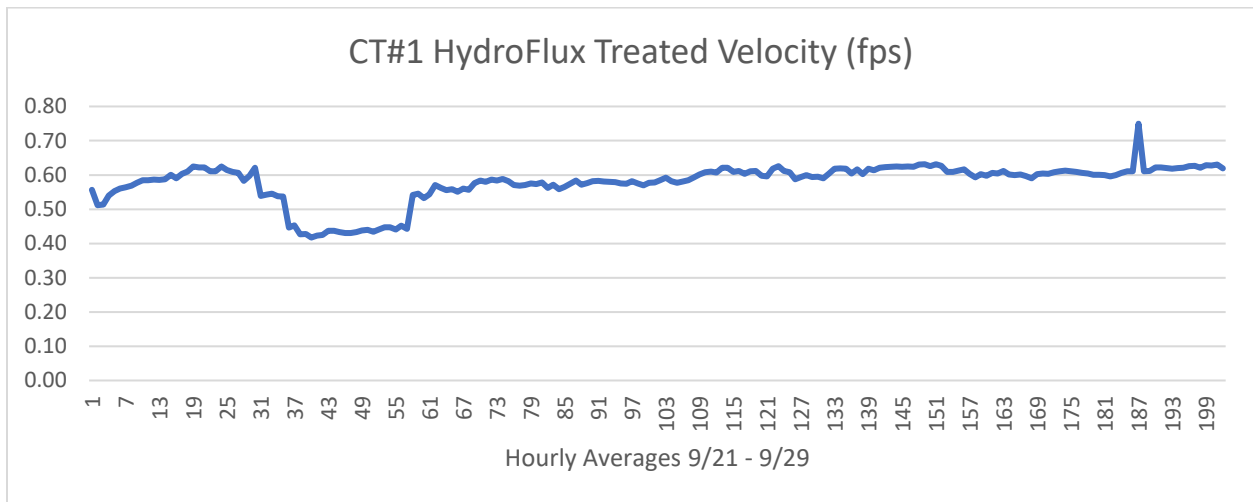
Deposition appeared on each of the tubes initially due to the very low velocity in the exchangers, 0.5fps. The following is a graphic analysis of the velocity control during the exposure period.

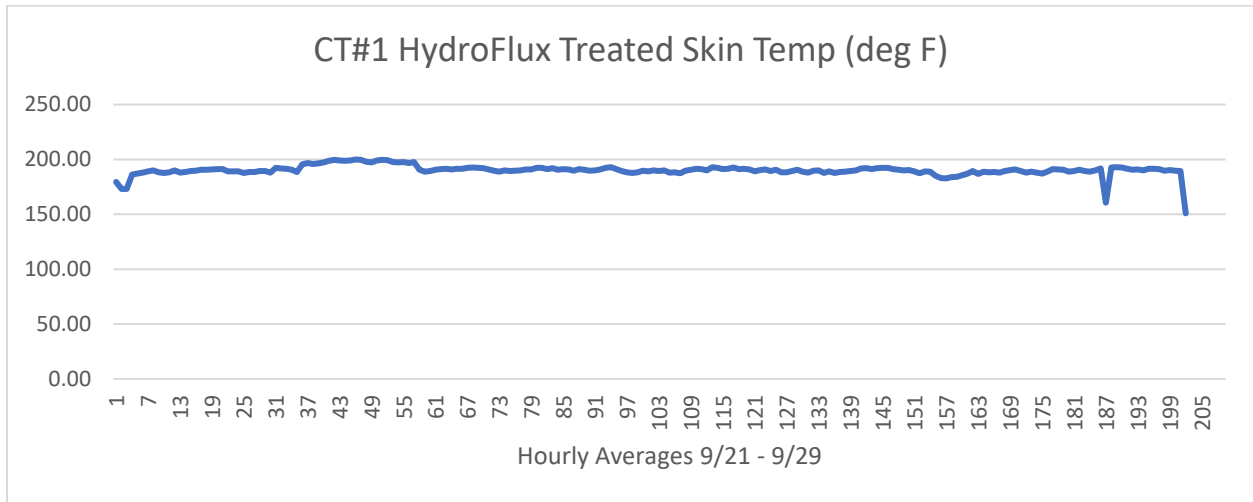
Another significant stress on this system during the exposure period was the high skin temperature. The following is the control of the skin temperature during the study.

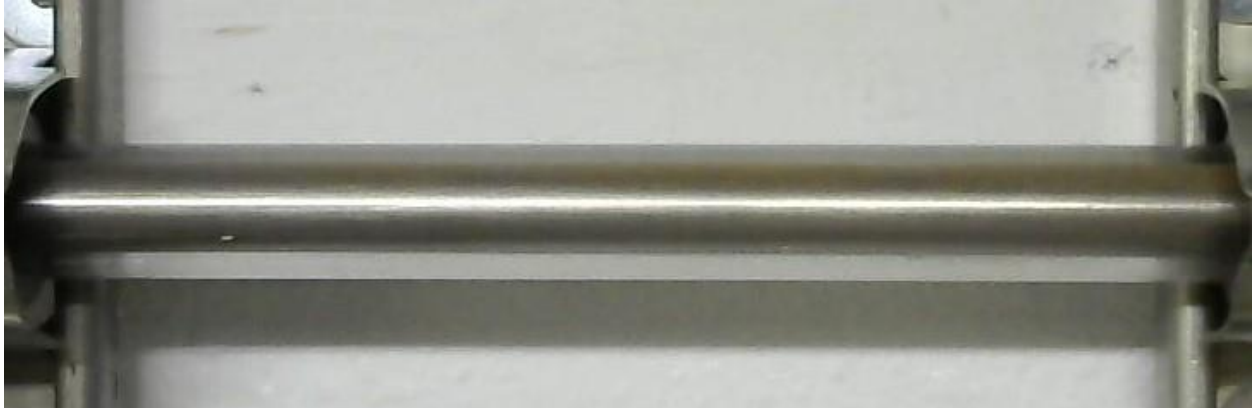
Early accumulation of deposit observed on the top of the HydroFlux treated specimen.

As seen in the video, as time progressed it was obvious that the deposition formed in the control (untreated system) began to grow around the circumference of the specimen, unlike the treated system where the deposited material only accumulated on the top of the tube.

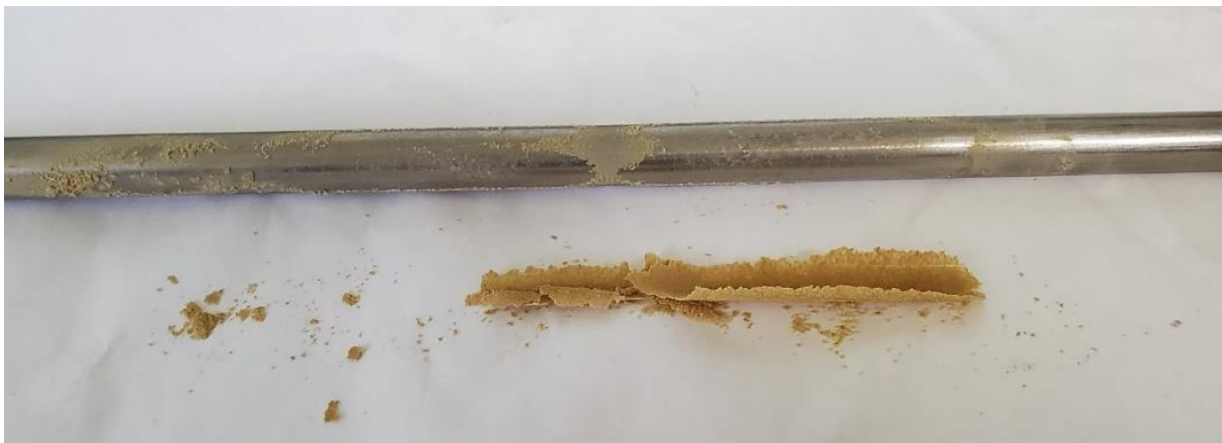
When rolling the specimens over to photograph the opposite side the treated specimen's deposit was shed from the tube.

In the chart below the tube was weighed a second time to capture the amount of deposit that simple fell off the top of the tube.
